# Manhole Inspection Summary

Manhole # S51M\_\_067MH

Insp Date: **2/3/09 9:18 AM**

**Location** Address: **POTOMAC-CURLEY-ALLEY**

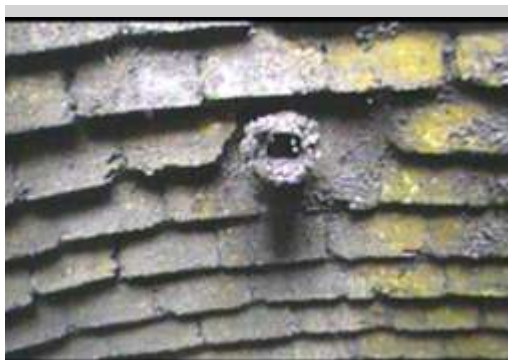
MISC.

PIPE INTRUSION @ 6 OCLOCK IN THE CORBEL

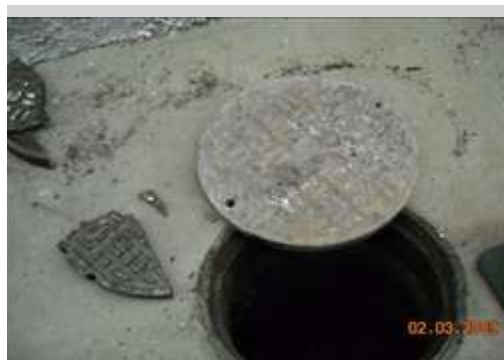
MISC

REPLACED BROKEN COVER

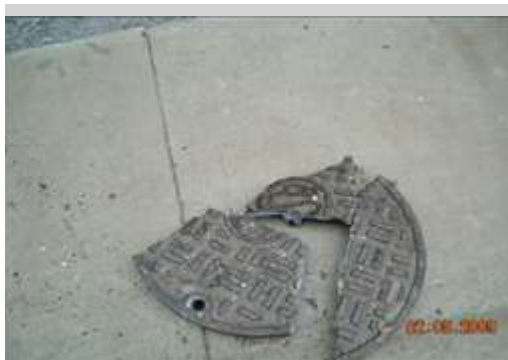
MISC

Comments **BROKE AND REPLACED 24INCH COVER (see photos)**

BROKE COVER TO GAIN ACCESS

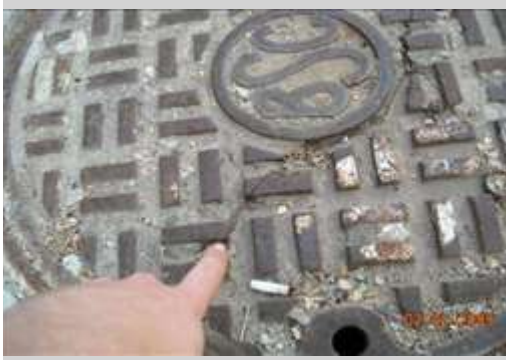
### MISC

cracked cover shown before opening and replacing broken cover

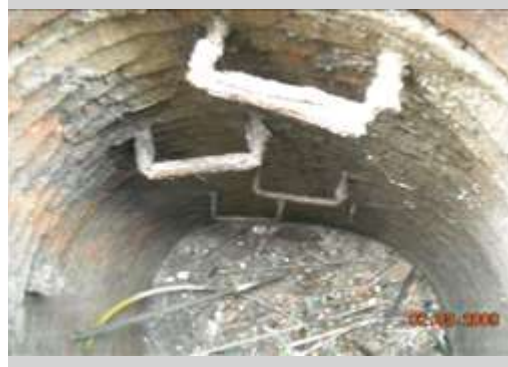
### Defect 2

☒ **Corroded**

CORRODED STEPS

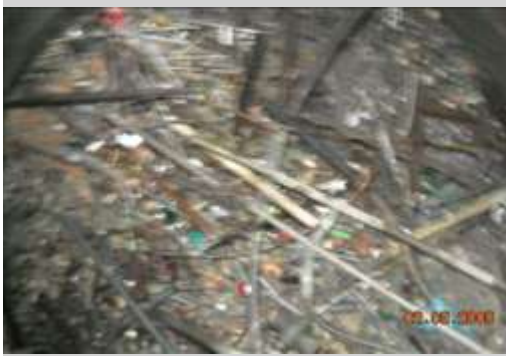
### Defect 1

Condition: ☐ Sound ☐ Cracked ☐ Root Intrusion ☐ Deteriorated ☐ Leaks ☒ **Debris**

DEBRIS IN TERMINAL CHANNEL

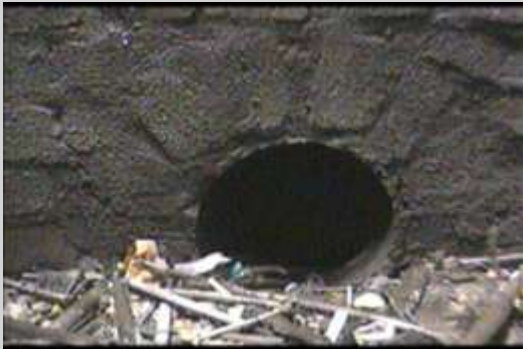
12 O'Clock Outflow

8 in. Circular Gravity Sewer  
Pipe Out @ 12 O'Clock

Deposits: ☐ None ☒ **Mud** ☐ Sludge ☒ **Debris** ☐ Grease

Silt Depth: **1** (in.) Deposits Extent: **Light**
